Case Study

Locating Leaks on AC Pipe

Bellwood, PA

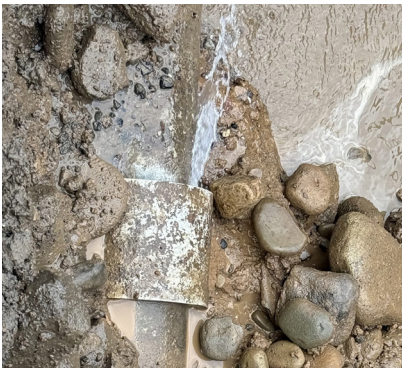
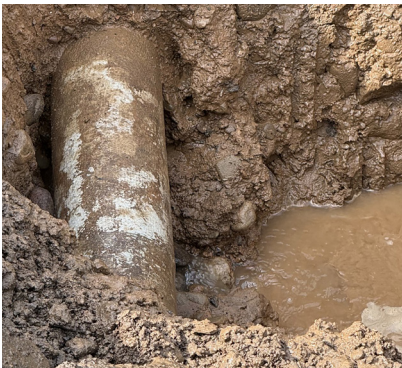
Data from the Gutermann Cloud platform not only showed steadily increasing leak score values, but also revealed strong, high-quality correlations between multiple loggers. The system quickly identified a very difficult leak with 100% correlation quality. The leak was on a 700' long 6" section of asbestos cement pipe.

Showing deployed loggers with 100% correlation.

Using this information, the Bellwood water team was able to accurately pinpoint the leak location in the field. The issue was successfully repaired during normal working hours, minimizing disruption and water loss.
